STAYING ABOVE WATER

Property Owner's Guide

Greater Portland Landmarks

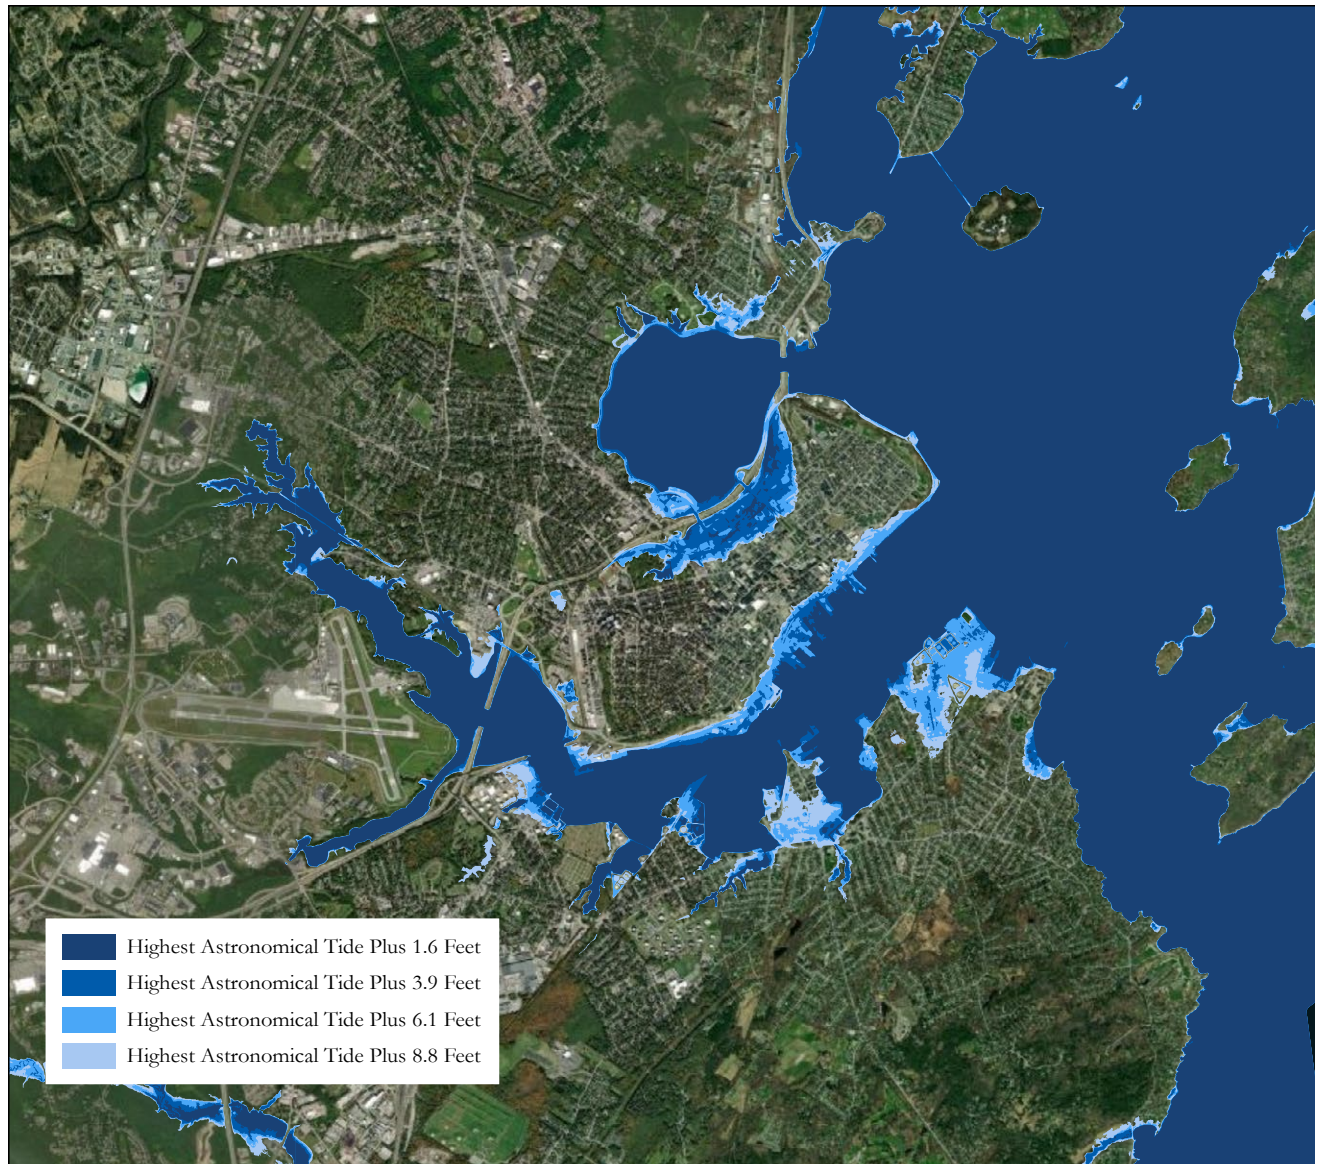
Sea Level Rise and Storm Surge Scenarios in Greater Portland

The Scientific and Technical Subcommittee of the Maine Climate Council recommends committing to manage 1.5 feet of sea level rise (darkest blue) by 2050 and 3.9 feet by 2100. They recommend preparing to manage 3 feet of sea level rise by 2050 and 8.8 feet of sea level rise by 2100 (lightest blue).

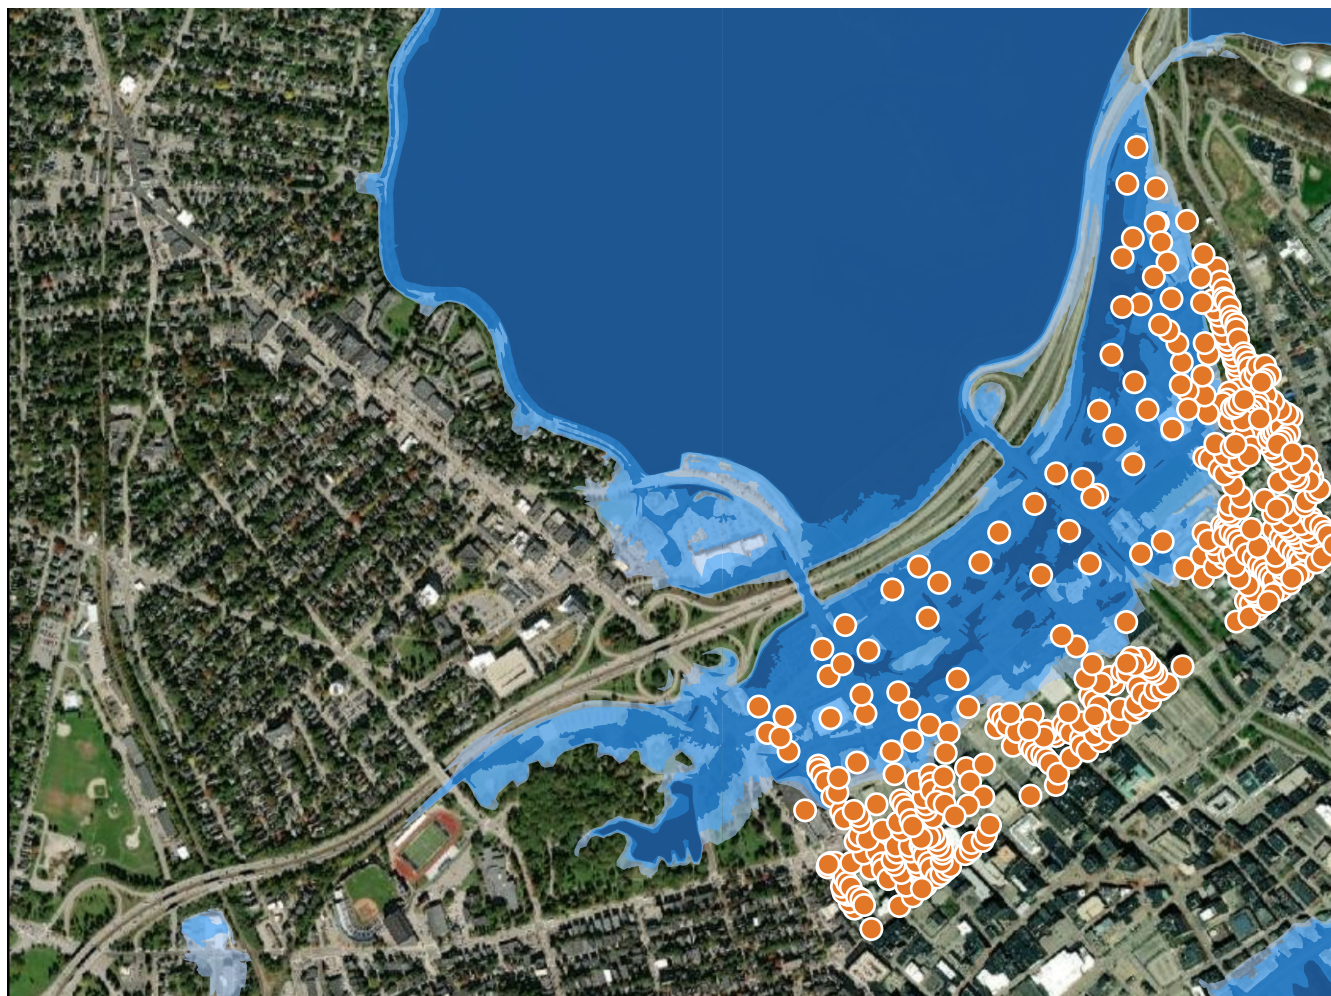
Each orange dot represents a surveyed historic resource in Bayside at risk due to increased flooding and sea level rise caused by climate change.

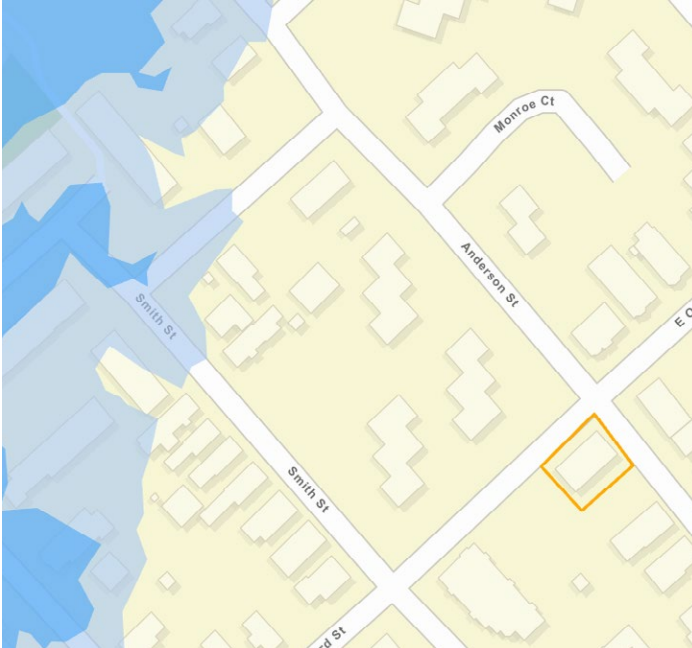
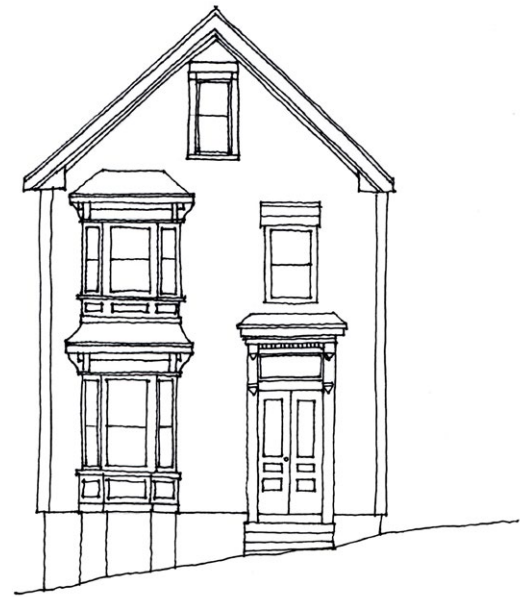
32 Anderson Street

This multi-family residence rests on a high foundation in an elevated area in Bayside. Although not identified as at risk to flooding from rain and storm surges, storm water runoff from uphill sites and parking lots to the rear of the dwelling could impact the masonry foundation and at-grade openings. There are few trees to shade the southwest-facing yard. The lot could be improved to encourage site drainage away from the building's foundation.

- Install solar panels on the south slope of the roof, set back from the edge of the gable end
- Elevate critical mechanical systems on the interior
- Resize gutters to handle increasing precipitation loads and drain away from foundation.
- Install rain barrels or integrate gutter runoff into landscaping strategies
- Slope grade and landscaping away the foundation on the uphill side of the house to help drainage
- Install hardware around openings at grade level to accommodate retractable flood shields during storm events
- Reduce impermeable paving, particularly uphill of the dwelling

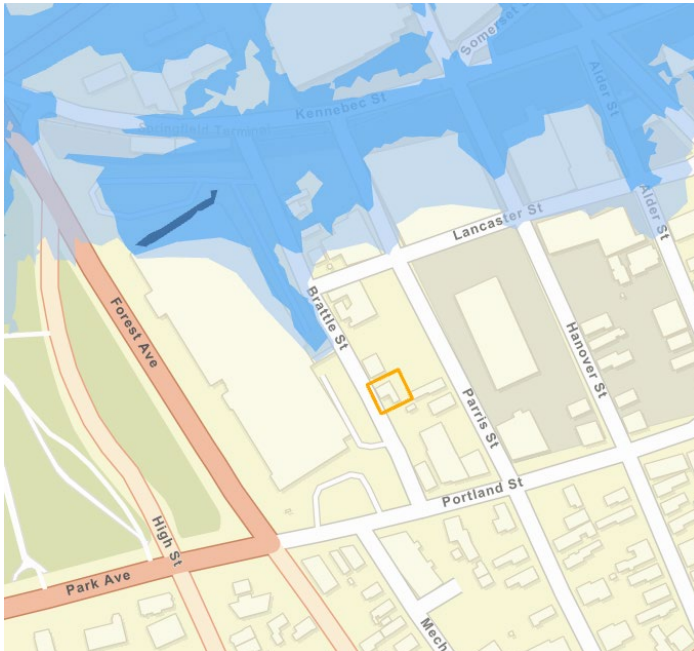
17 Brattle Street

This single-family residence rests on a high foundation in an elevated area in Bayside. Although not identified as at risk to flooding from rain and storm surges, storm water runoff from nearby paved streets and parking lots uphill and across the street from the dwelling could impact the masonry foundation and at-grade openings. A large deciduous tree shades the south-facing side yard. The lot could be improved to encourage site drainage away from the building's foundation.

- Install solar panels on the ell roof or main roof, set back from the edge of the gable end
- Elevate critical mechanical systems on the interior
- Integrate rainwater run off strategies into landscaping
- Maintain masonry, particularly chimneys to reduce damage from loose falling bricks and water infiltration
- Install hardware around openings at street level to accommodate retractable flood shields during storm events
- Slope grade and landscaping away from the foundation on the uphill side of the house to improve site drainage

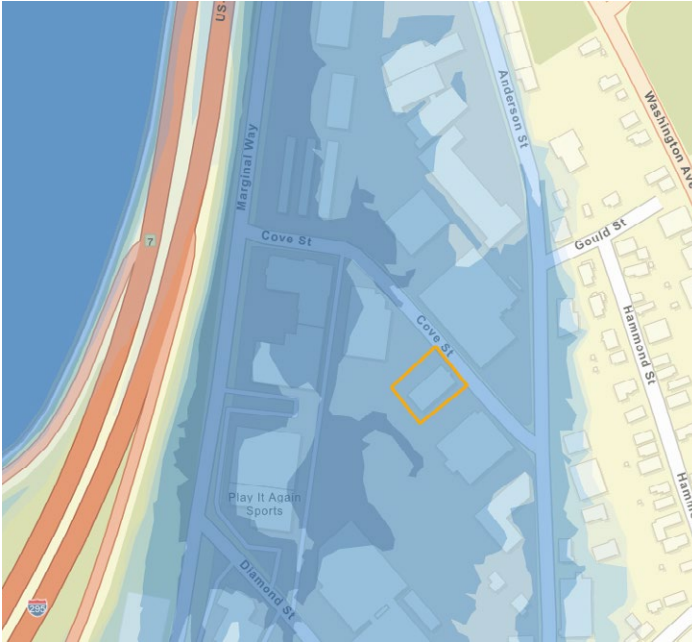
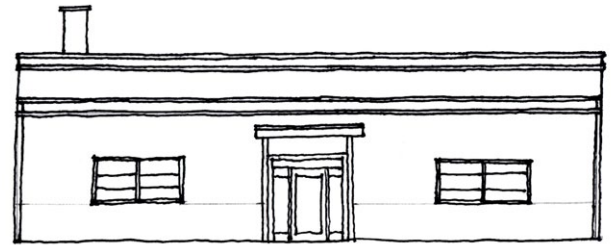
66 Cove Street

This industrial brick building (c.1953) is typical of many of its small-scale neighbors, built in an section of Bayside that was once part of Back Cove until it was filled in the first half of the 20th century. The area currently experiences nuisance flooding during extreme storm and high tide events. The at-grade entrance is vulnerable to street flooding. Likewise, mechanicals systems on the exterior, and possibly the interior, are at risk from street flooding. Impermeable paving in the parking area surrounding the building does not allow storm water to penetrate into the ground and raises the temperature more than a vegetated surface would do.

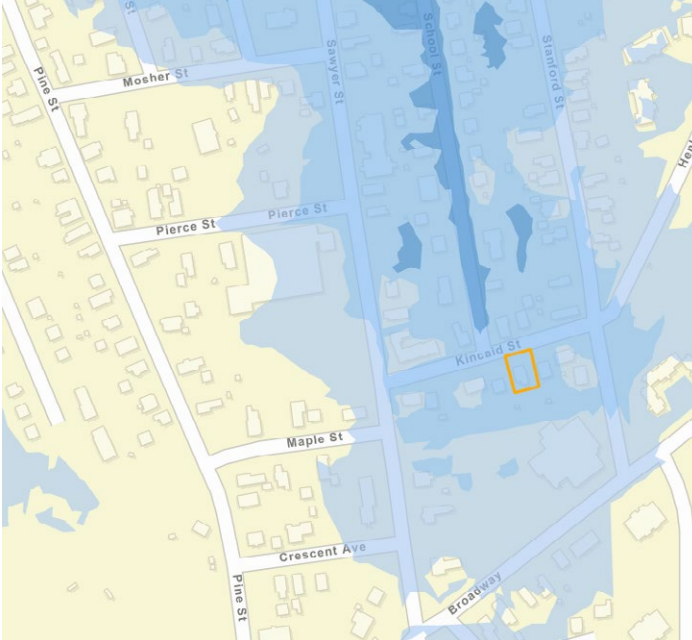
16 Kincaid Street

This single family residence rests on a high foundation at the edge of a low-lying area in Ferry Village identified as at risk to flooding from rain and storm surges. Buildings in this area were anecdotally noted during the study to have wet basements during some major rain events. Large trees shade the south-facing rear yard. The relatively flat lot could be improved to encourage site drainage away from the building's foundation.

- Elevate critical mechanical systems on the interior
- Integrate rainwater run off strategies into landscaping
- Maintain masonry, particularly chimneys, to reduce damage from loose falling bricks and foundations to prevent water infiltration
- Slope grade and landscaping away the foundation to help drainage
- Reduce impermeable paving in the driveway
- Add trees where possible to help lower temperature by providing shade
- Install solar panels on the rear roof slope

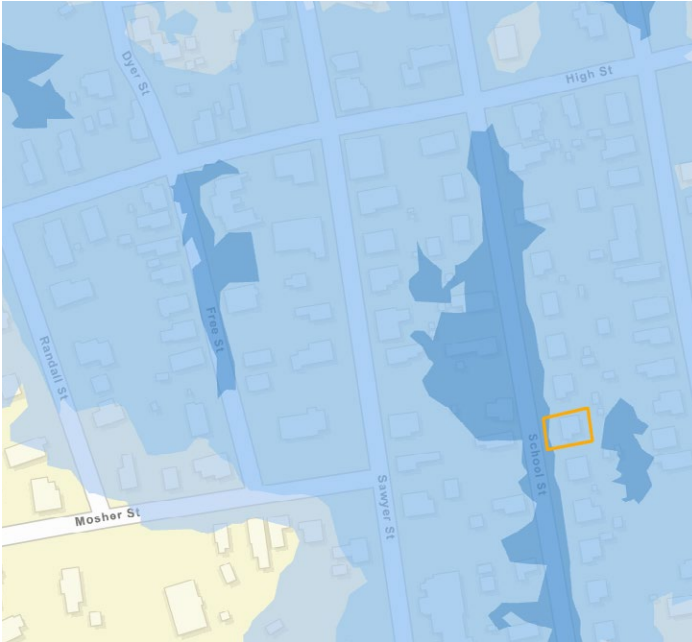
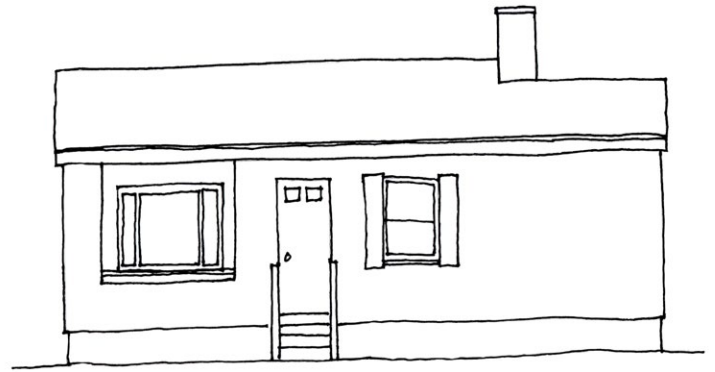
154 School Street

This single-family residence is slightly elevated above street level, in a low-lying area of Ferry Village identified as at risk to flooding from rain and storm surges. Buildings in this area were anecdotally noted during the study to have wet basements during some major rain events. Basement windows on the side elevations are at or near grade and are potentially vulnerable to flooding. Elevated levels of ground water could also impact the basement, damaging critical mechanical systems.

- Install solar panels on the roof or site
- Elevate critical mechanical systems on the interior
- Integrate rainwater run off strategies into landscaping
- Maintain masonry, particularly chimneys to reduce damage from loose falling bricks
- Slope grade and landscaping away the foundation to help drainage
- Reduce impermeable paving in the driveway
- Add trees where possible to help lower temperature by providing shade
- Install hardware around basement windows to accommodate retractable flood shields during storm events

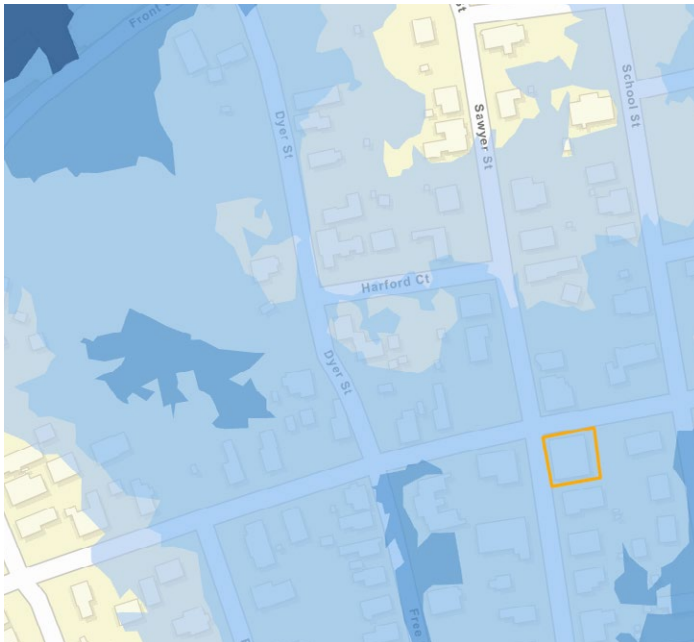
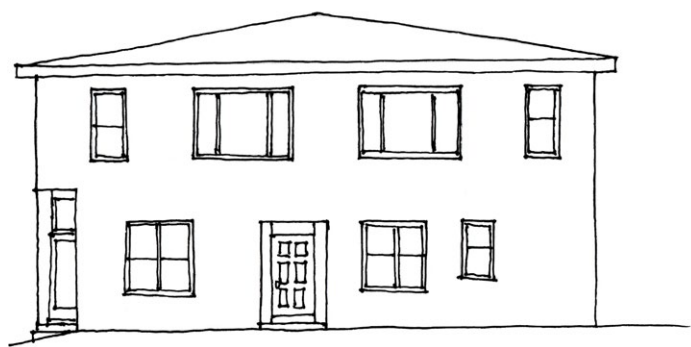
124 Sawyer Street

This mixed-use building at the corner of two major streets is located close to the sidewalk on two sides of the building and surrounded by paved parking on the two remaining sides. This low lying area of Ferry Village has flooded during historic storm events. Entries at or near grade are vulnerable to street flooding. Impermeable paving in the parking area does not allow storm water to penetrate into the ground and raises the temperature more than a vegetated surface would do.
